Proposed Vegetation Management Plan for the Area between the ARRC Security Fence South of Northpointe Bluff Dr and the ARRC Anchorage Rail Yard on Government Hill (Revision 8/31/2023)

Project Overview

Project Area

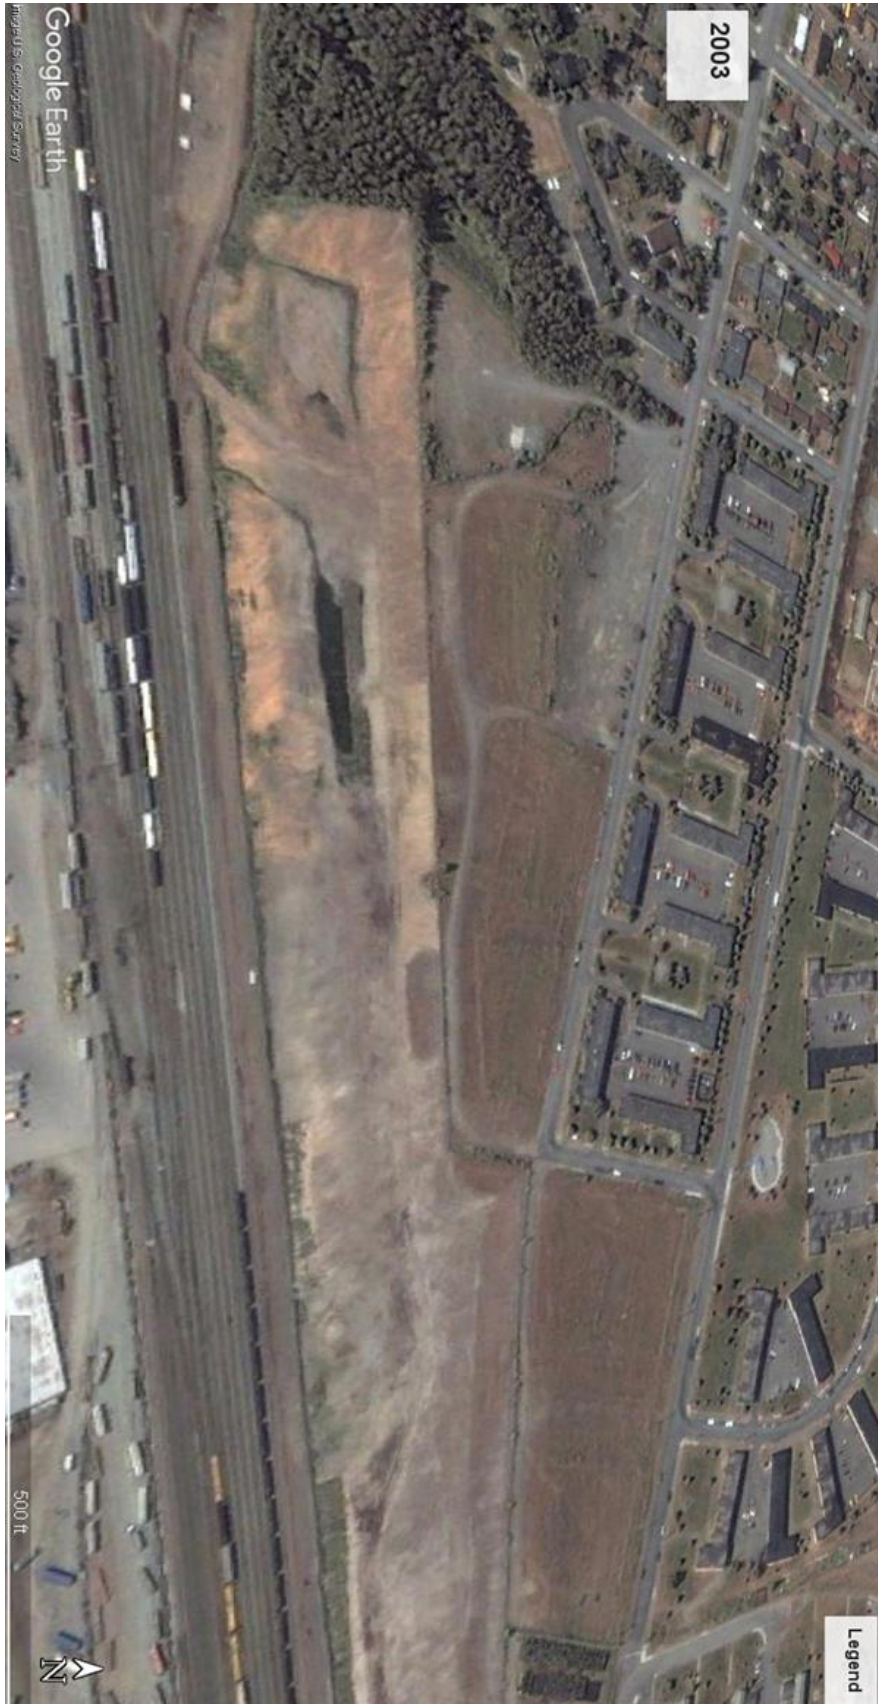
Attachment 2

The ARRC land south of the Northpointe Bluff subdivision, including what is now the MOA leased greenbelt referenced in this vegetation plan, was graded to its current condition in approximately 2003, see Attachment 2. Much of the natural occurring tree growth in the area was mowed by Hydro-Axe in 2010. The current fence was installed, and spruce trees planted approximately every 30 feet along the south side of the fence the same year.

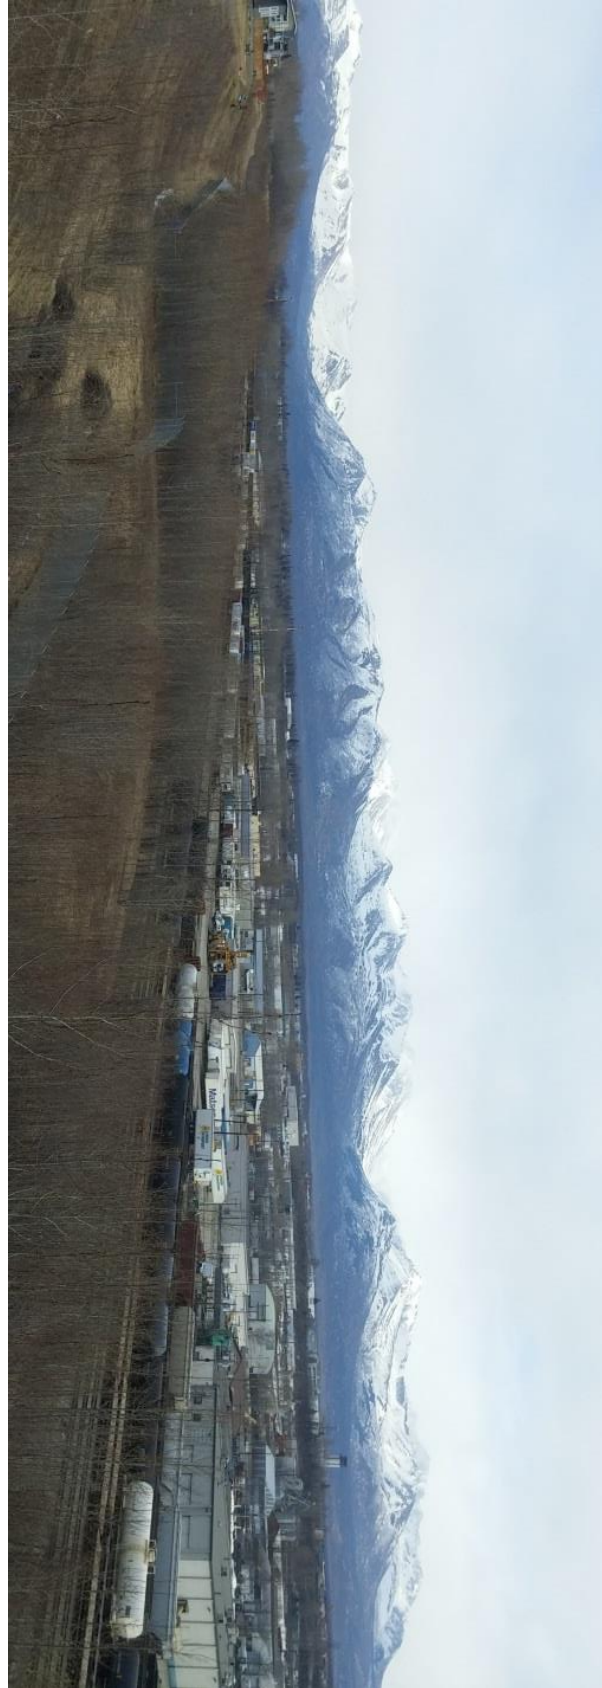
Attachment 4

Several public overlook opportunities exist in the greenbelt, see attachments 4.
