RUNWAY 15/33
REHABILITATION
AND WIDENING
2019

2019 PROPOSED AIRPORT CONSTRUCTION PROJECTS*

SIGNIFICANT 2019 ANC CONSTRUCTION PROJECTS

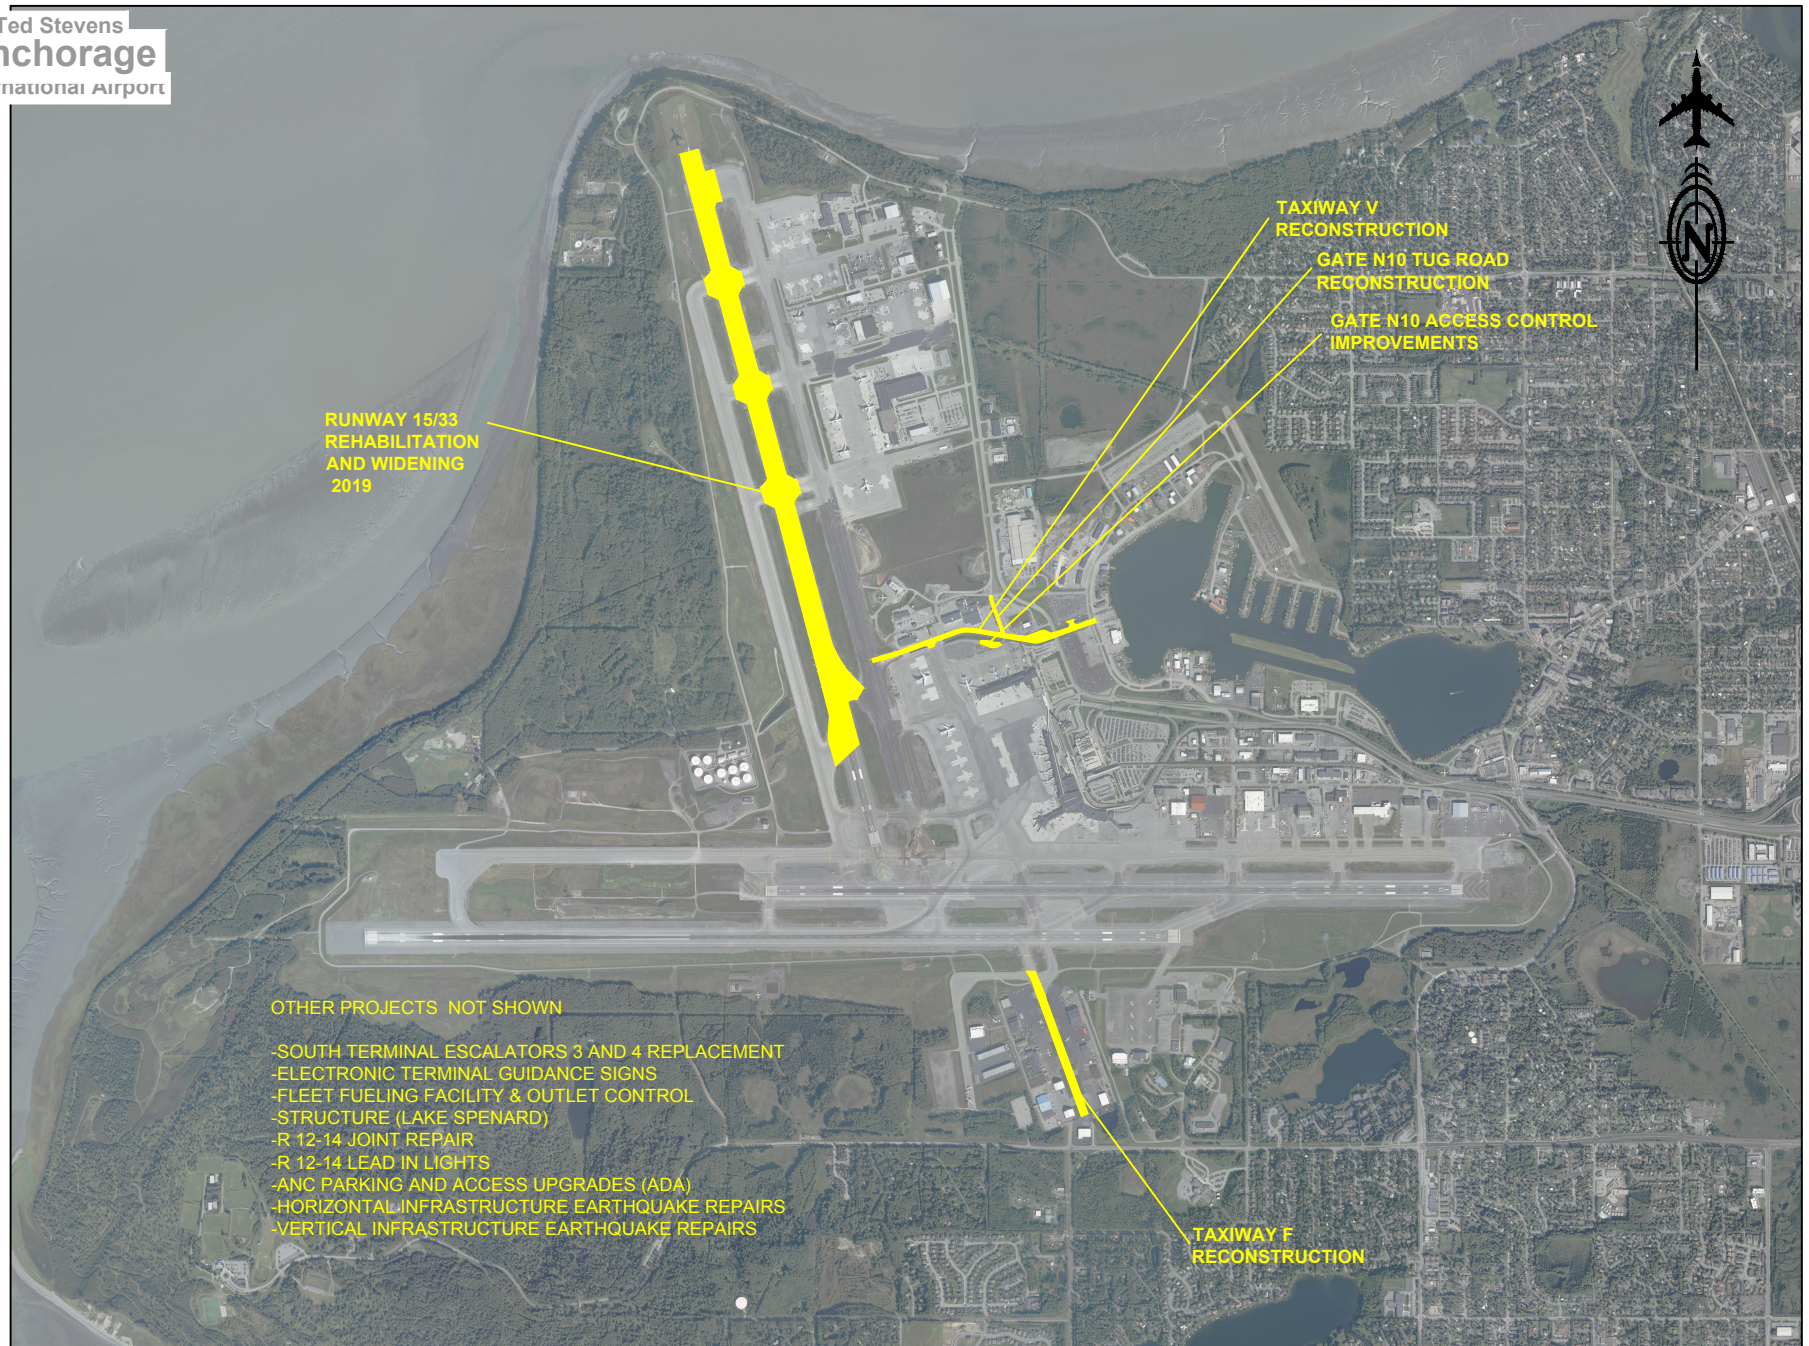
TAXIWAY V
RECONSTRUCTION

GATE N10 TUG ROAD
RECONSTRUCTION

GATE N10 ACCESS CONTROL
IMPROVEMENTS

OTHER PROJECTS NOT SHOWN

- SOUTH TERMINAL ESCALATORS 3 AND 4 REPLACEMENT
- ELECTRONIC TERMINAL GUIDANCE SIGNS
- FLEET FUELING FACILITY & OUTLET CONTROL
- STRUCTURE (LAKE SPENARD)
- R 12-14 JOINT REPAIR
- R 12-14 LEAD IN LIGHTS
- ANC PARKING AND ACCESS UPGRADES (ADA)
- HORIZONTAL INFRASTRUCTURE EARTHQUAKE REPAIRS
- VERTICAL INFRASTRUCTURE EARTHQUAKE REPAIRS

TAXIWAY F
RECONSTRUCTION
